# Data Evaluation Report, 2019 Residential Soil Sampling, Old American Zinc Plant Superfund Site, Fairmont City, St. Clair County and Madison County, Illinois

Work Assignment No. 224-RDRD-B5A1, Contract No. EP-S5-06-01

PREPARED BY: CH2M HILL, Inc. (CH2M)

DATE: January 6, 2020

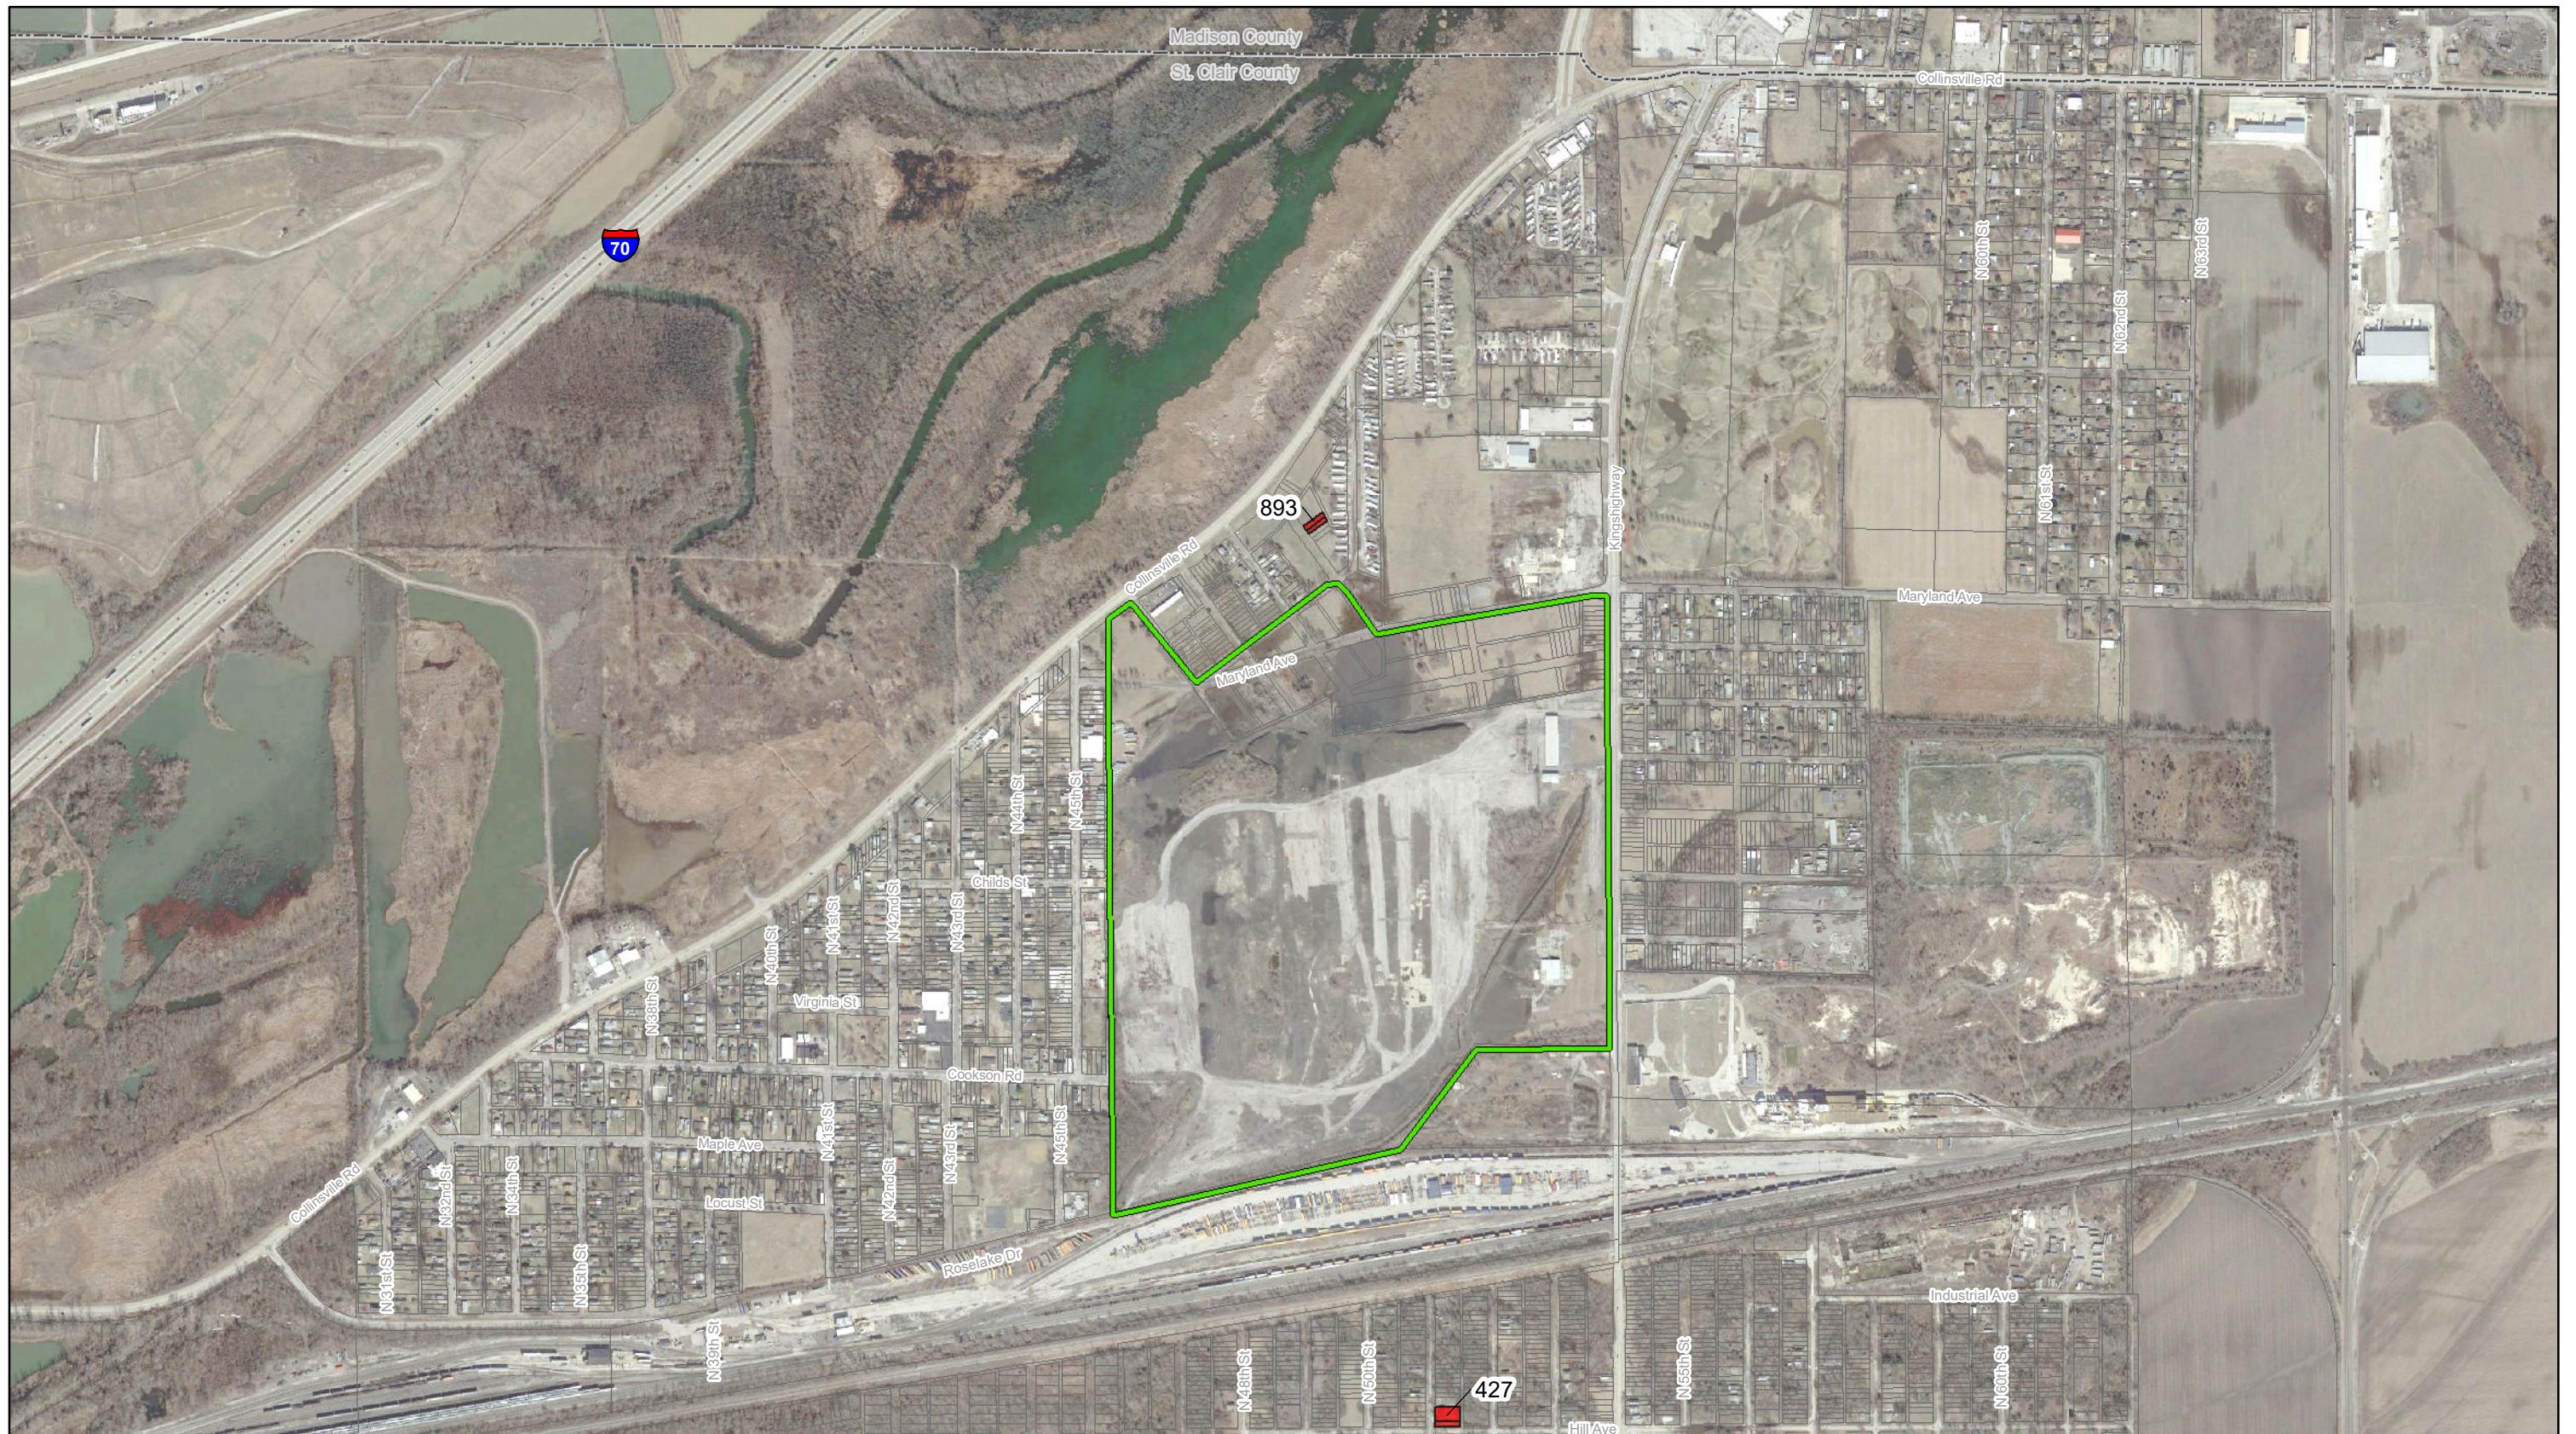
**Figure 3**  
2019 Sampling - Cadmium Concentrations Above Residential Soil Cleanup Level  
*Old American Zinc Plant Superfund Site*  
Fairmont City, St. Clair County and Madison County, Illinois

The average cadmium concentration at residential properties sampled in 2019 was found to be 6.66 mg/kg. A total of 10 out of 604 samples exceeded the residential CL of 37 mg/kg, for an overall exceedance frequency of 1.7 percent by sample and 4.5 percent by property. Forty percent of the exceedances occurred in the depth interval ranging from 0 to 6 inches, 40 percent in the 6- to 12-inch interval, 0 percent in the 12- to 18-inch interval, and 20 percent in the 18- to 24-inch interval. On a per-property basis, 2 out of 44 properties exceeded the cadmium CL (Figure 3).

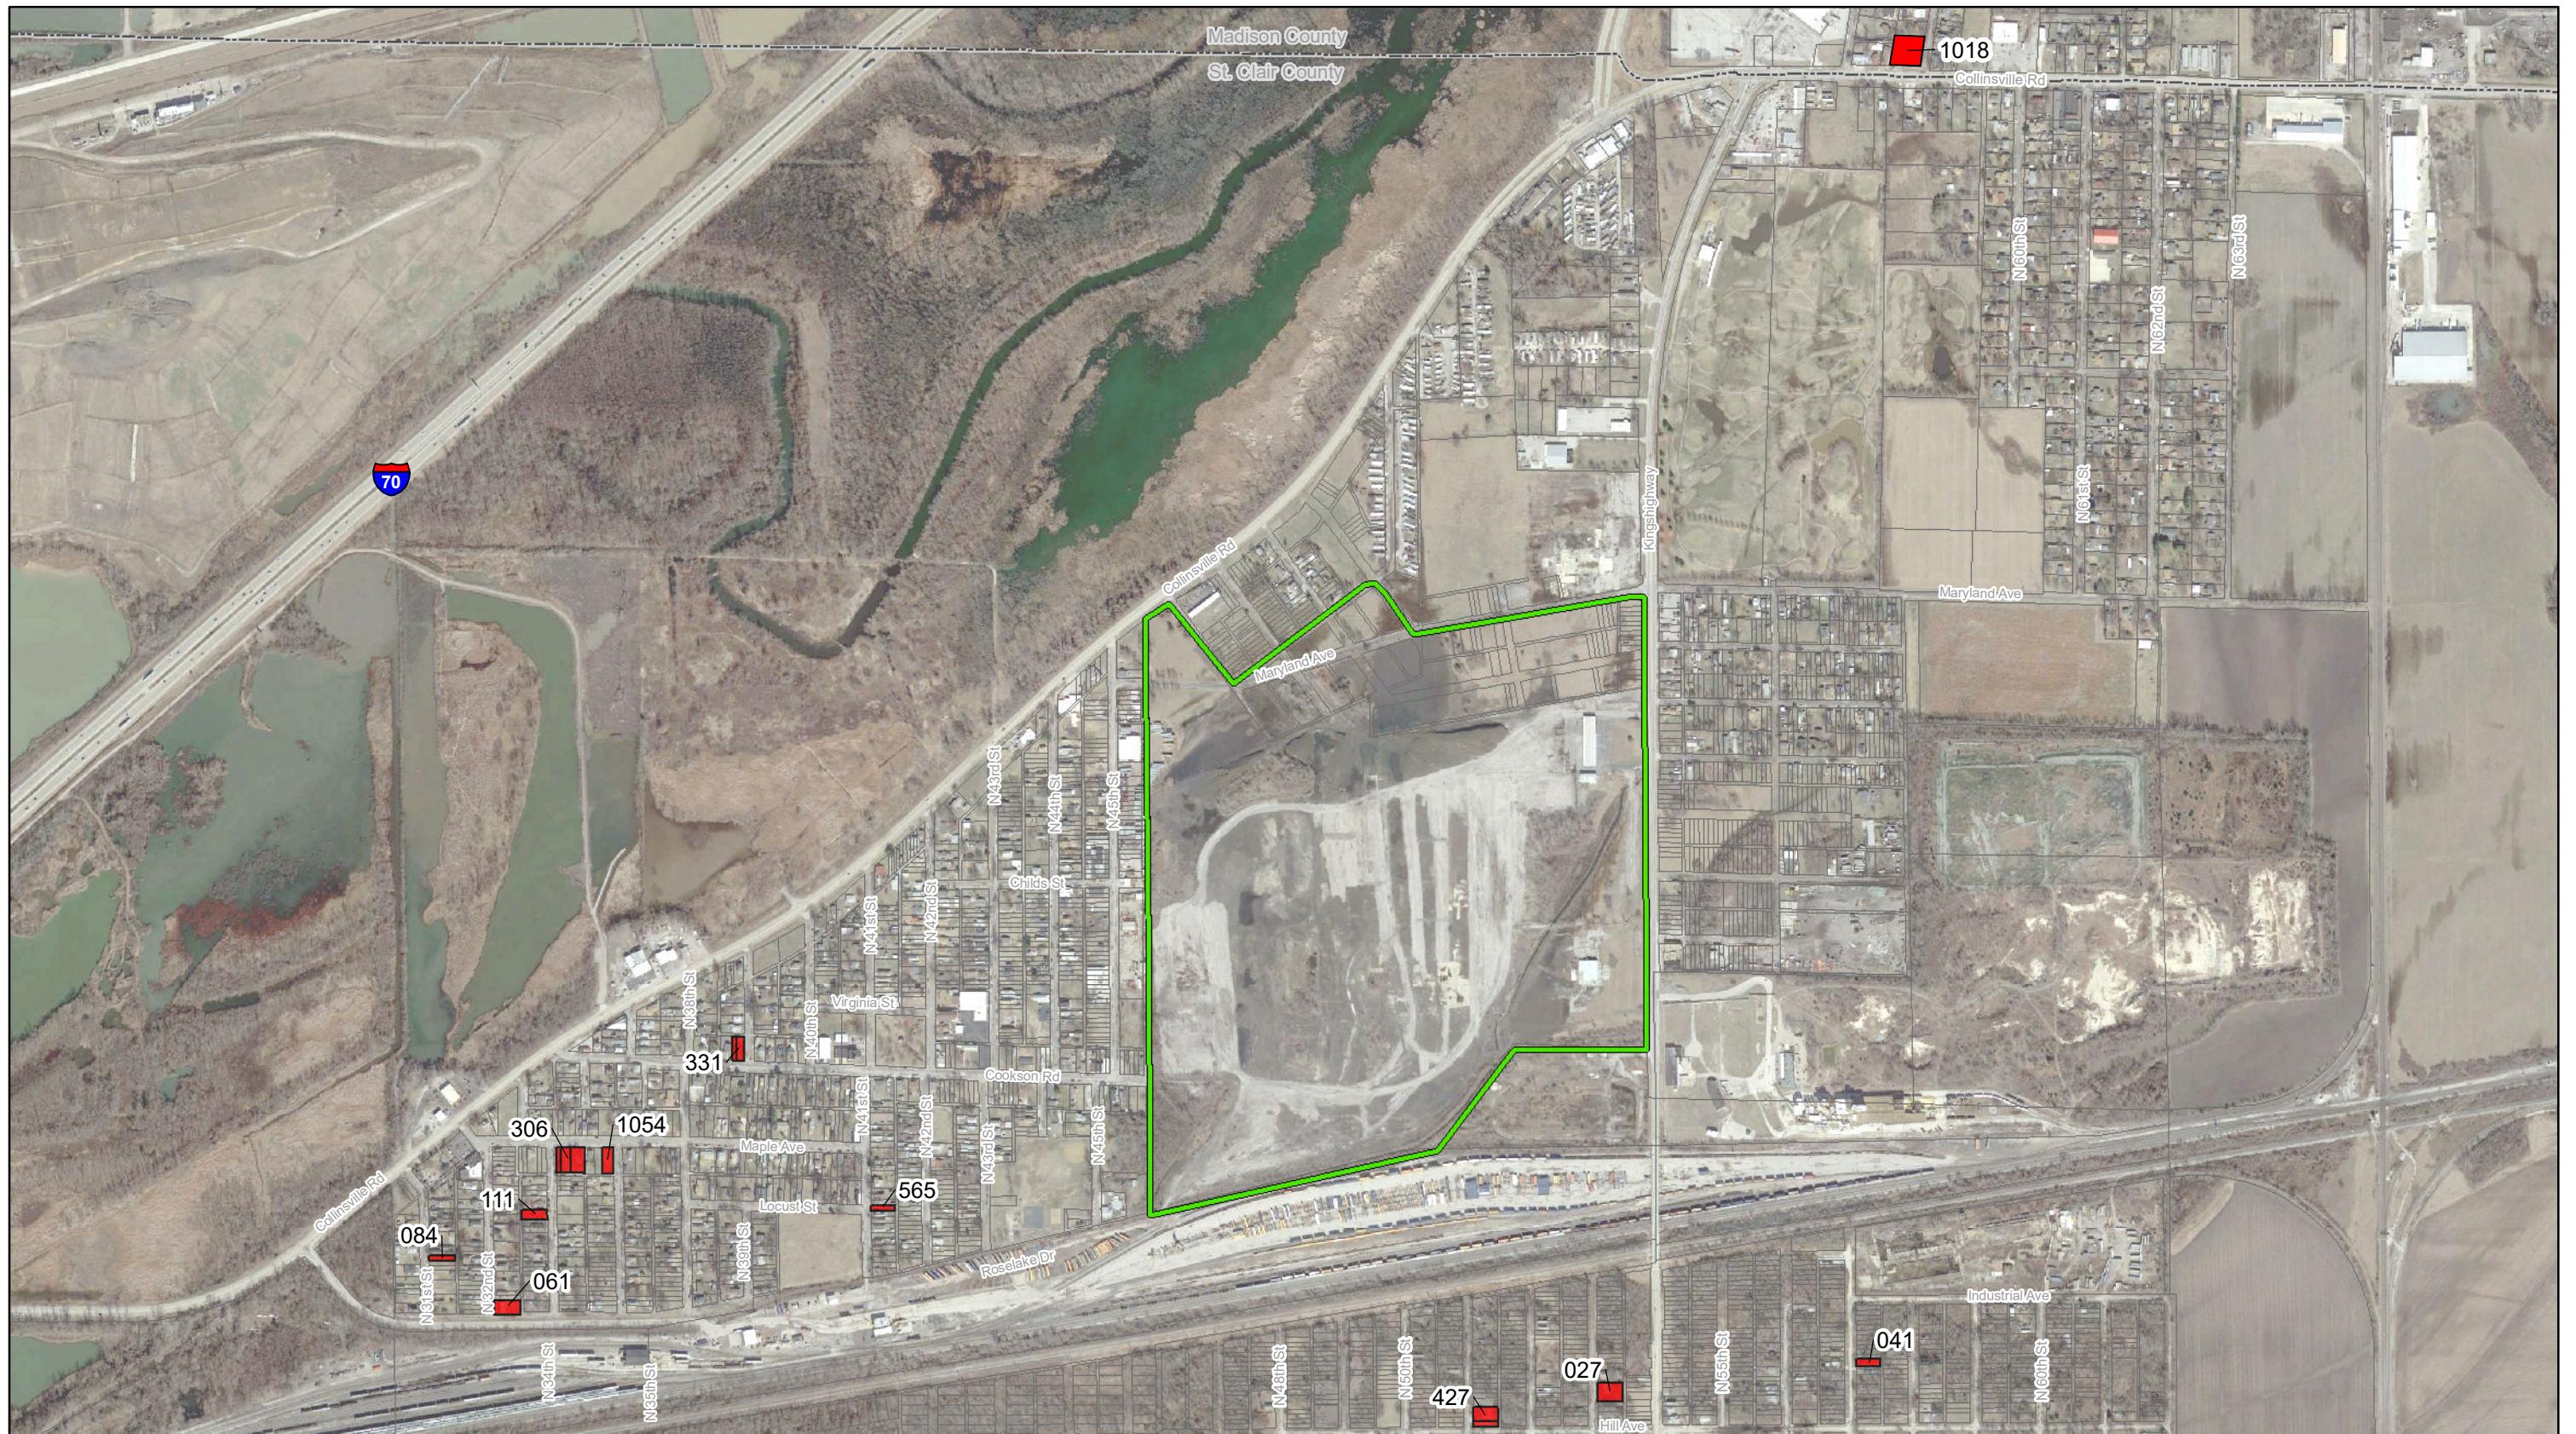
The average lead concentration at residential properties sampled in 2019 was found to be 96.16 mg/kg. A total of 18 out of 604 samples exceeded the residential CL of 400 mg/kg, for an overall exceedance frequency of 3 percent by samples and 25 percent by property. Fifty-six percent of the exceedances occurred in the depth interval ranging from 0 to 6 inches, 16 percent in the 6- to 12-inch interval, 16 percent in the 12- to 18-inch interval, and 11 percent in the 18- to 24-inch interval. On a per-property basis, 11 out of 44 properties exceeded the lead CL (Figure 4).

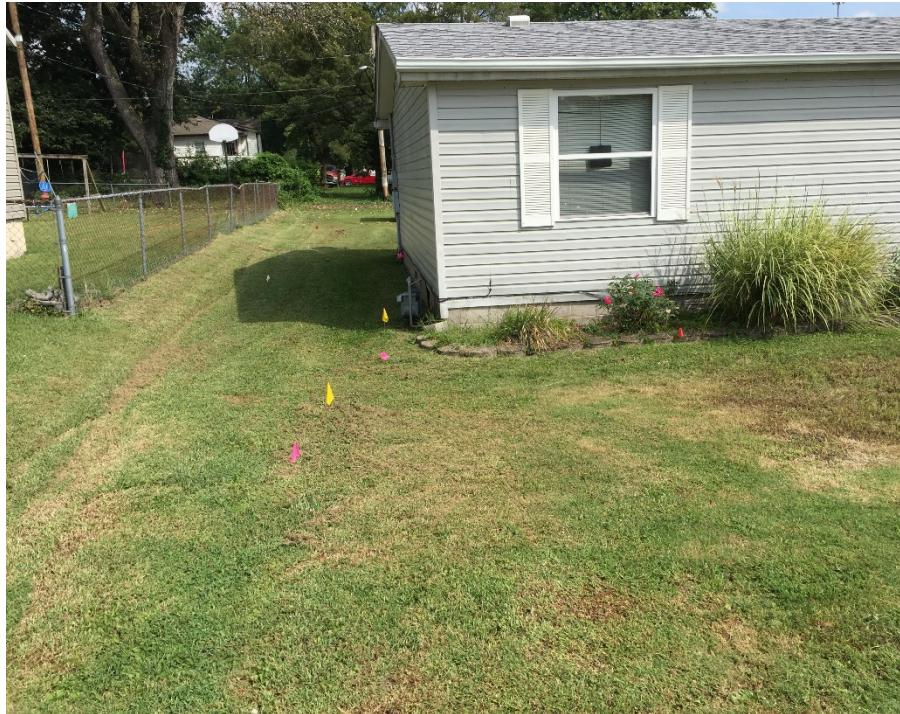
*Photo 1 - Utility flags and markings in side yard.*

Prior to sampling, public utilities were marked by placing a utility-locate request through JULIE, Illinois' One-Call system. Private utilities within each property were marked by a third-party utility-locate subcontractor, Ground Penetrating Radar Systems, Inc. Utilities were marked using the American Public Works Association Uniform Color Code System. Prior to intrusive work, CH2M also conducted a visual inspection of each property for utilities and, if the homeowner was available, asked them about private utilities on the property.

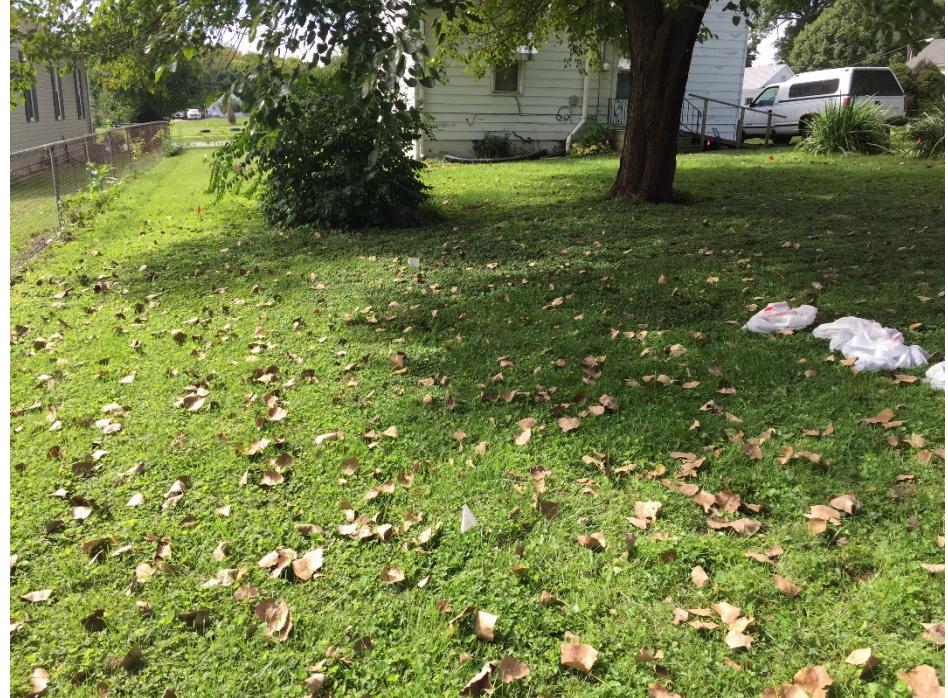
*Photo 4 – Utility flags and sampling flags, and liners.*

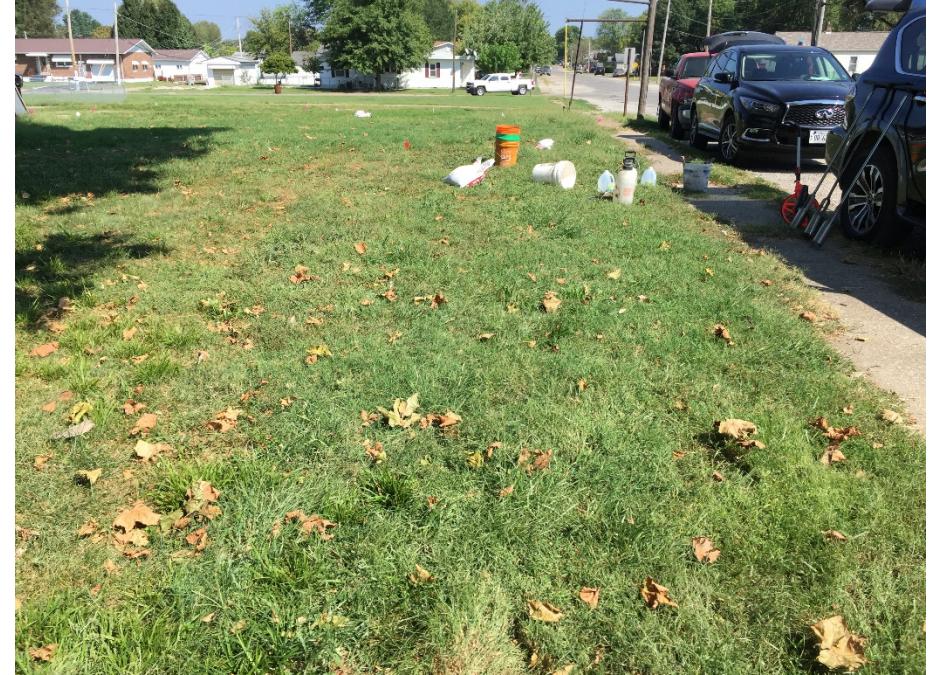
Photo 6 – Decontamination equipment, containers, fill soil and augers.

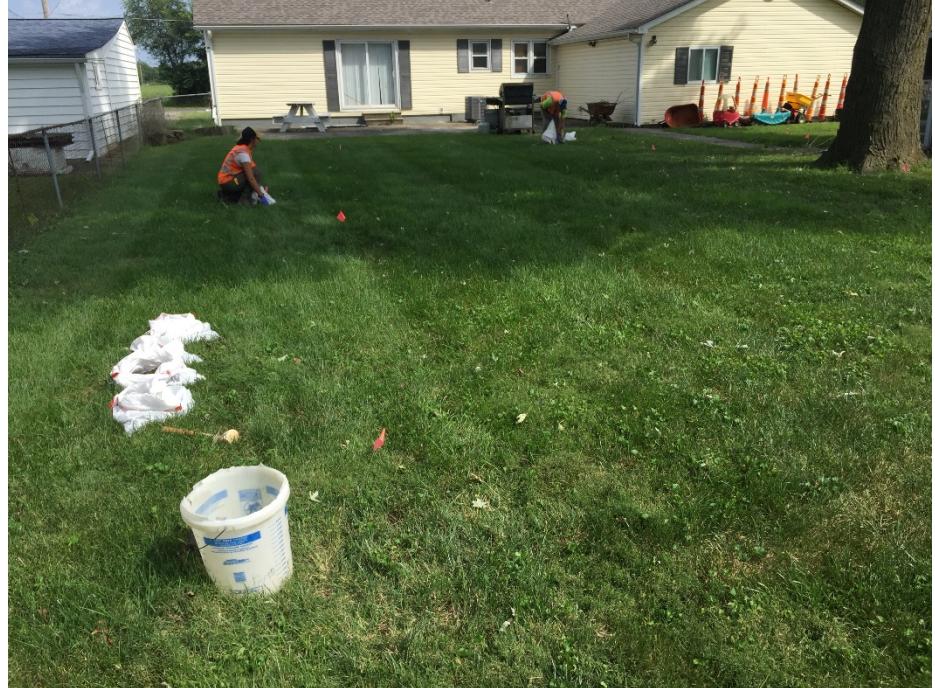
Photo 8 – Hand auger staff abandoning sampling points with excess soil.

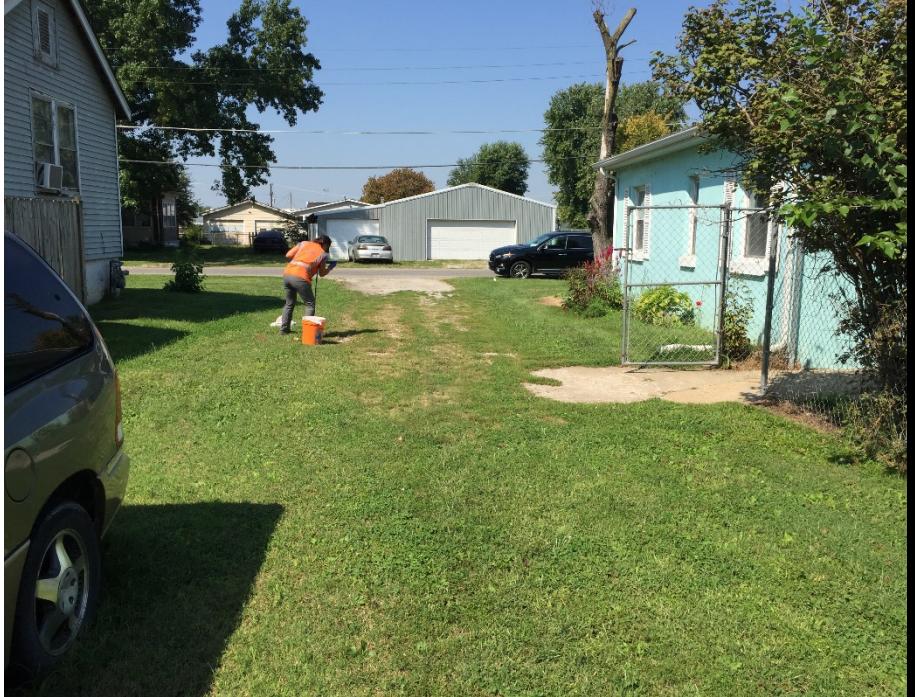
Photo 9 – Hand auger staff collecting sample aliquots.

Soil samples were collected using a hand auger from 5 points within a section and in 6-inch intervals up to a depth of 24 inches (0 to 6, 6 to 12, 12 to 18, and 18 to 24 inches). Approximately 4 ounces of soil was collected from each of the 5 points per depth interval and homogenized using stainless-steel spoons in a bucket lined with a disposable liner. Rocks, miscellaneous debris, and vegetation were removed before the composite sample was placed in a jar. A total of four samples was collected per yard area or section (excluding QA/QC samples). The samples were submitted to the laboratory for analysis.

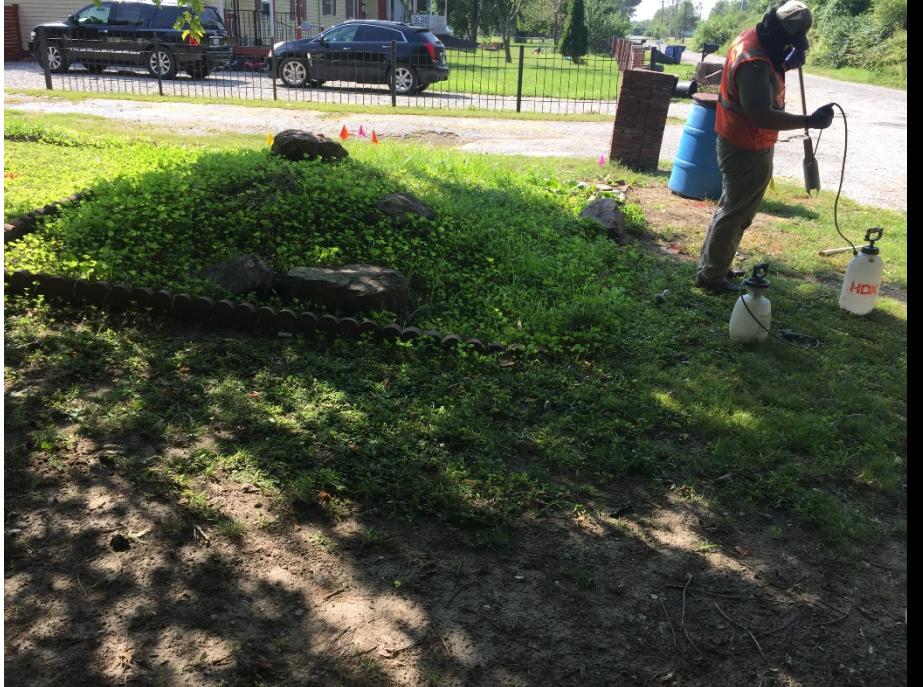
Photo 11 – Hand auger staff performing decontamination.

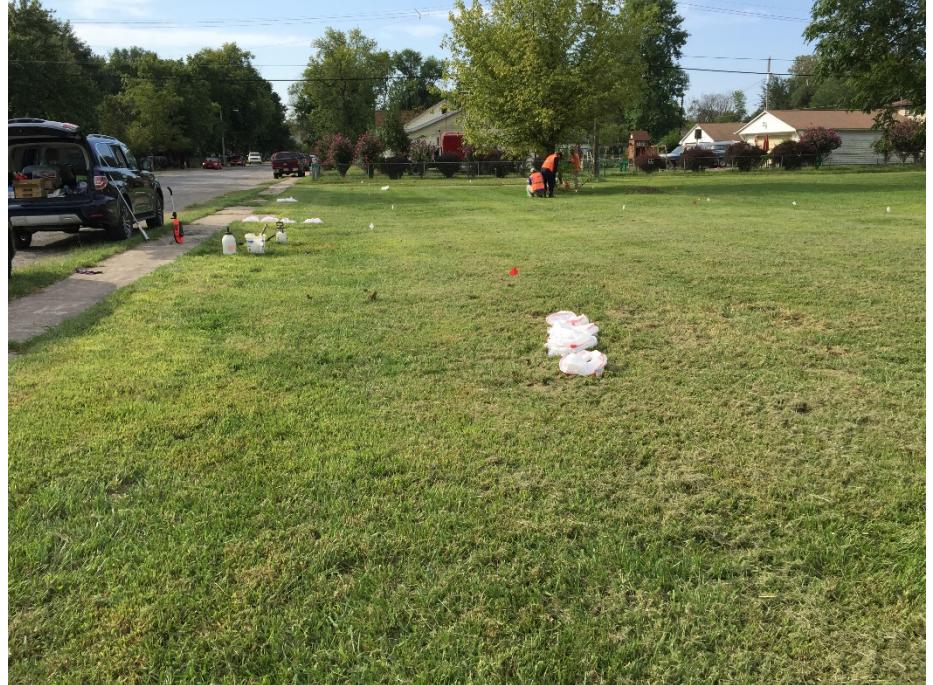
Photo 12 – Sample liners and hand auger staff; decontamination equipment on left.
